Locating Complex Apical Anatomy Post GentleWave® Procedure

CLINICIAN: Brian T. Wells, DMD

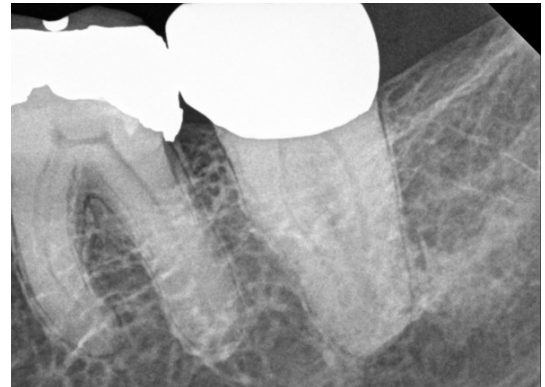
Figure 1. Pre GentleWave® Procedure

Following endodontic treatment referral, a seventy-six-year-old male presented with pain to function for five days. Clinical and radiographic examination of the mandibular left second molar (#18) lead to a diagnosis of pulpal necrosis with acute apical periodontitis.

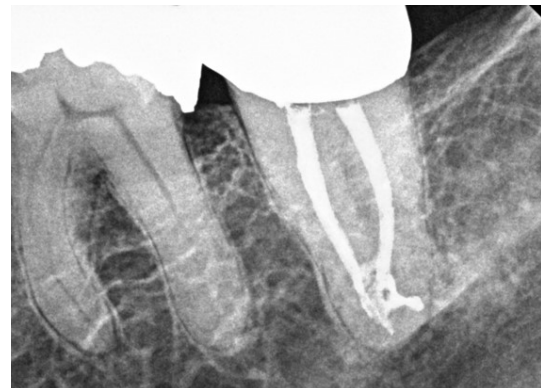
Figure 2. Post GentleWave® Procedure

The patient was anesthetized and the tooth was isolated with a rubber dam. Instrumentation was accomplished utilizing rotary files for a final apical diameter of #15. The GentleWave® Procedure was utilized after instrumentation to remove pulp tissue remnants, debris, smear layer and bacteria. All root canals were obturated using a warm vertical condensation technique with gutta-percha and Roth Root Canal Cement sealer. Two apical condensations were utilized during obturation. After obturation, a complex apical anatomy was visible between the mesial and distal canals. This anatomy was not known prior to the GentleWave Procedure and therefore additional shaping was not completed for preparation of these complexities.
